RICS
Building Survey...

Property address

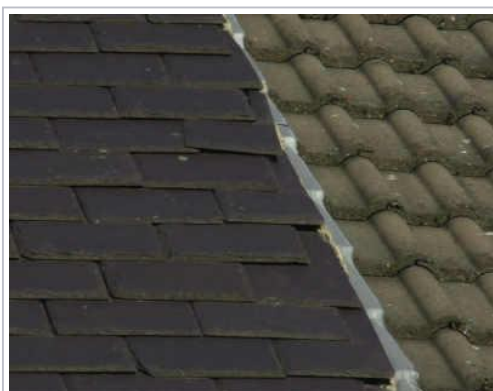
IMG_0014.JPG

We noted a number of slipped slates in particular to the rear elevation and these should be replaced as necessary to ensure the roof remains watertight.

The flat roof to the front bay appears to be in satisfactory condition at the present time with no signs of water penetration to the underside. Flat roofs do however, have a limited lifespan and can be prone to sudden failure. You should anticipate ongoing repair and periodic renewal.

A reputable roofer should be asked to quote for replacement of slipped slates most to the rear elevation and the installation of ventilation to redundant chimney flues.

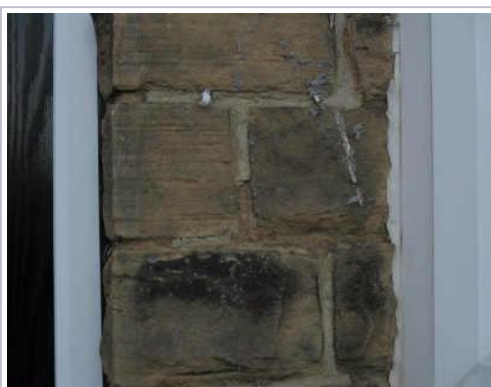
IMG_0006.JPG

We noted areas of defective pointing in particular to the front elevation and repairs are required to prevent damp penetration from entering the property. If any scaffolding is required, this will add to the cost.

It is vitally important to maintain air circulation within the void beneath the ground floors in order to prevent dampness, condensation and the development of rot. The existing sub-floor ventilation is inadequate and additional airbricks should be provided at a minimum of 1.5m centres.

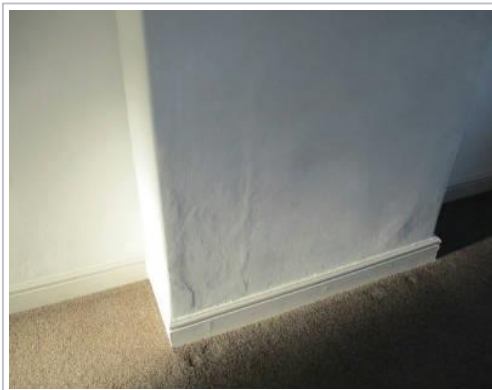
IMG_0050.JPG

We noted isolated dampness in the front lounge and rear dining area. At the time of our inspection this was at the lower end of the scale and is within acceptable tolerances. This should however, be closely monitored and if the problem worsens, specialist advice should be sought.

We noted further dampness affecting wall surfaces within the bathroom where the original chimney breast has been removed. The dampness is likely to originate either due to condensation within the remaining redundant flue at second floor level or alternatively maybe originating from the neighbours property if their chimney breast remains in-situ. It is recommended the redundant flues are ventilated and we would advise that the plasterwork is replaced with a sand and cement render incorporating a waterproofing agent and salt inhibitor before being re-skimmed with finishing plaster.

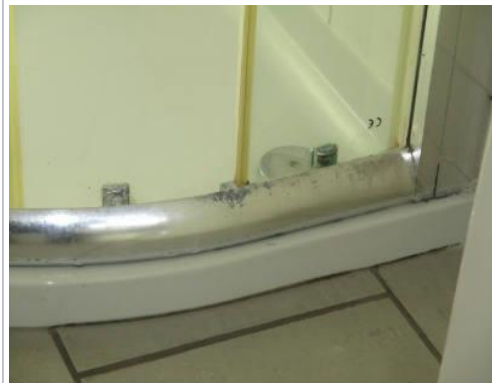
IMG_0053.JPG

The flexible sealant around the kitchen sink is in poor condition in places and should be renewed. Defects may be present in concealed areas and we recommend that you inspect these as a precaution.

We noted corrosion occurring to bathroom fittings due to condensation.
